APPENDIX K

SUBJECT: Cypress Bayou Water Management Study

PRELIMINARY ANALYSIS OF THE WATER QUALITY OF CADDO LAKE, TEXAS: RELATIVE EFFECTS OF WATER FLOW AND AQUATIC PLANTS

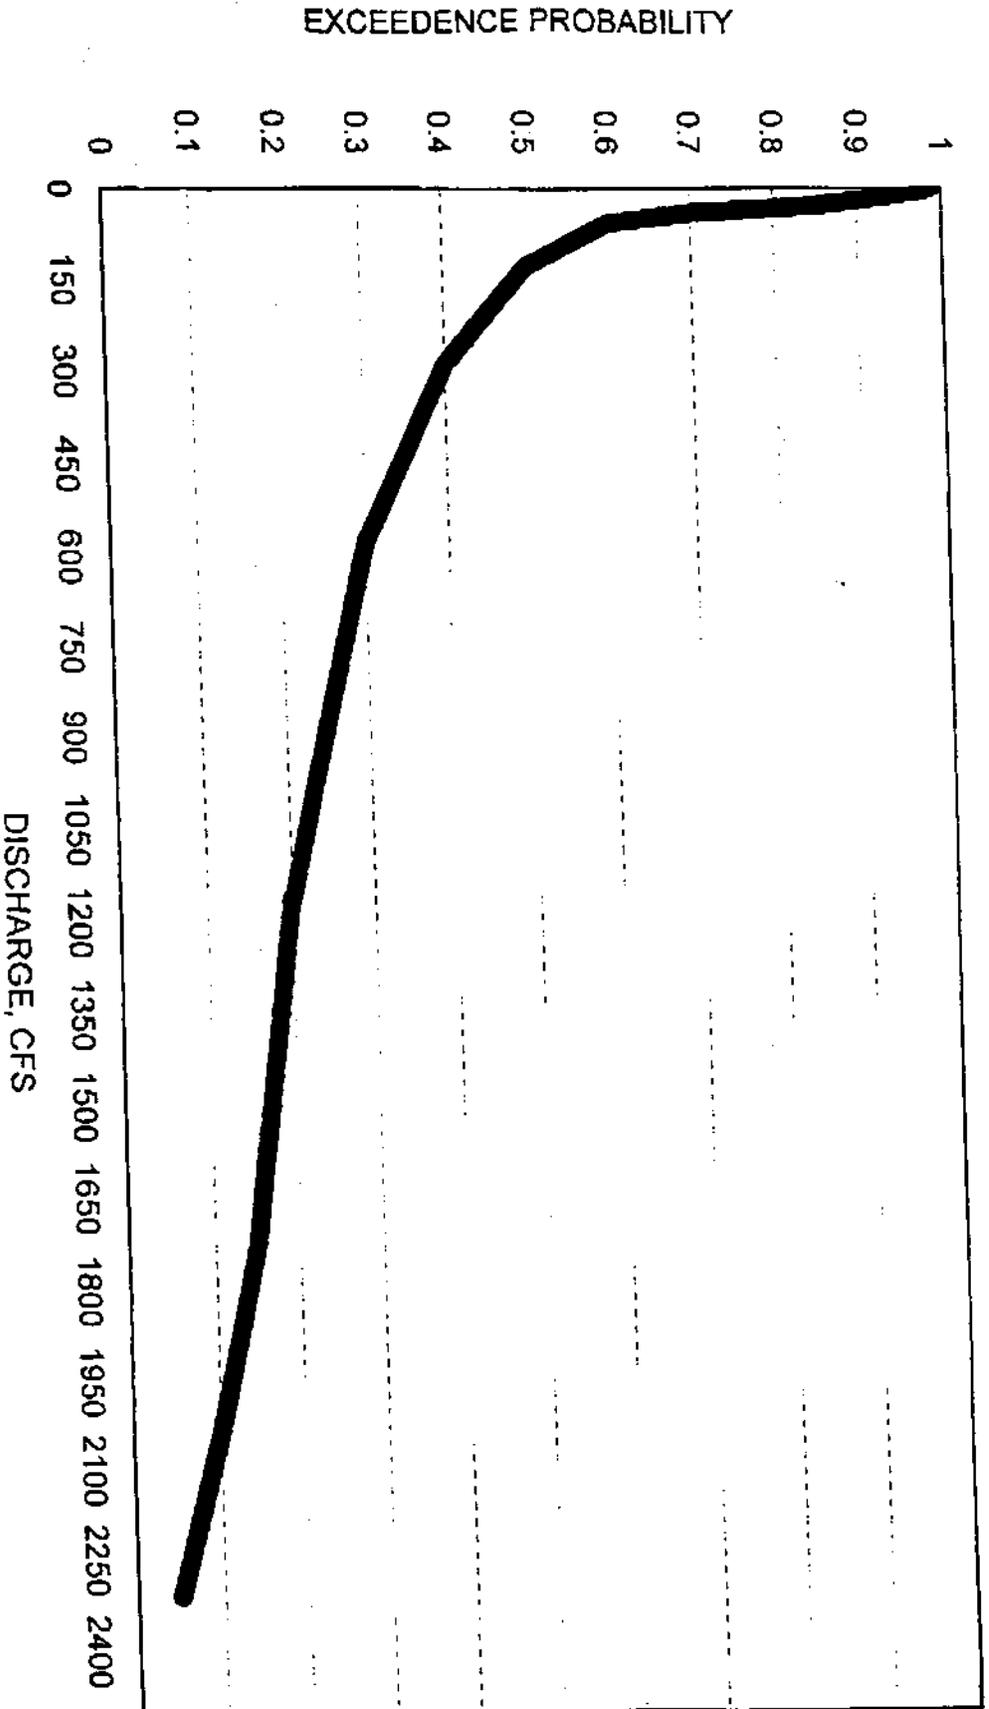
BIG CYPRESS BAYOU NEAR JEFFERSON, TX

ANNUAL FLOW DURATION CURVE: 1979-1993

9. Determining magnitude of flooding is problematic because both depth and volume of water must be considered. Depth of flooding should exceed bank-full discharge to ensure access to floodplain by laterally migrating fishes. High amplitude and subsequent decline in water elevation can be estimated from a flow duration curve (Figure 1). Based on gaging data obtained

near Jefferson, the median annual discharge is approximately 130 cfs which is well below bank-full discharge. Figure 1 shows that wet periods (10-20% exceedance) correspond to a range of 1,000 - 2,000 cfs. Thus, a conservative estimate on the high amplitude flood should occur between this range. GIS maps of floodplain habitats inundated at known flood frequencies (e.g., 2-year flood frequency) will improve the estimate since acreage by habitat (e.g., 200 acres of cypress trees) can be determined.

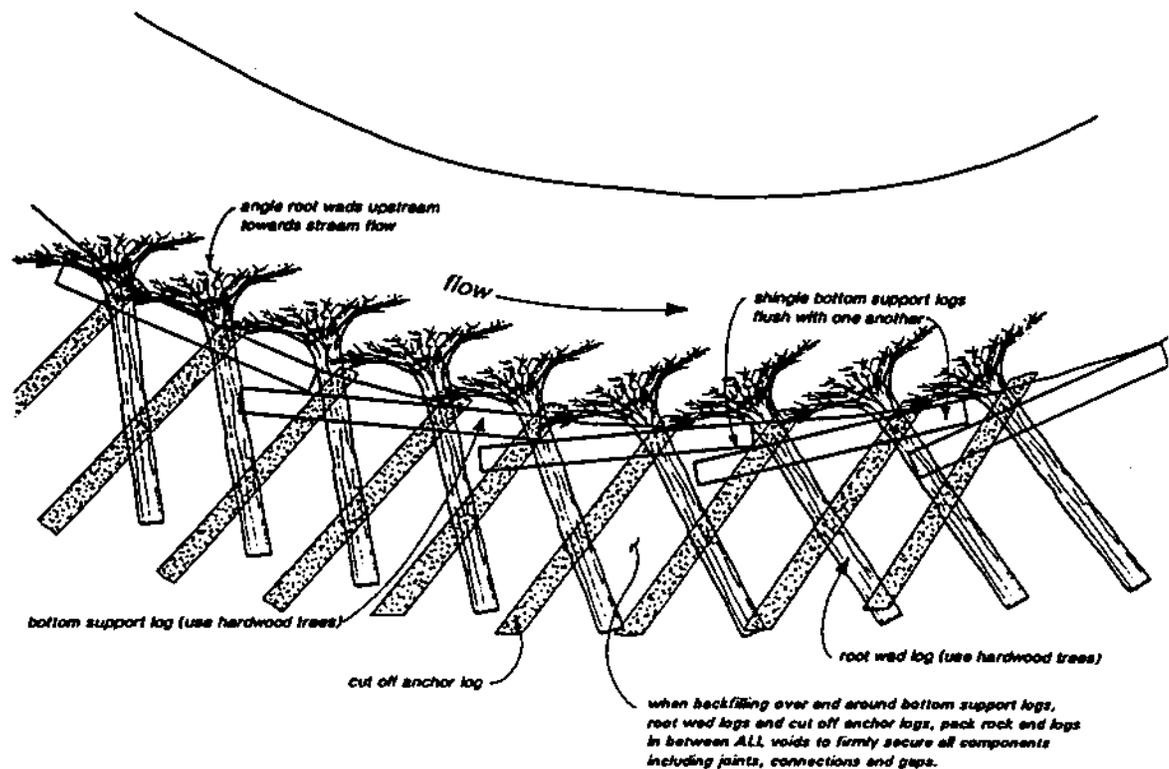
ROOT WAD CONSTRUCTION-PLAN VIEW

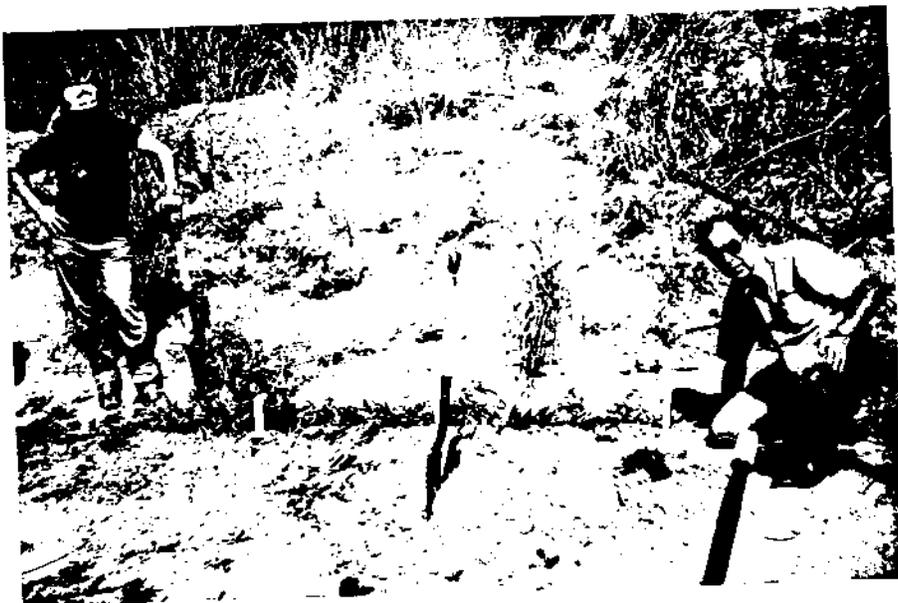
Figure 28. Completed wattling installation

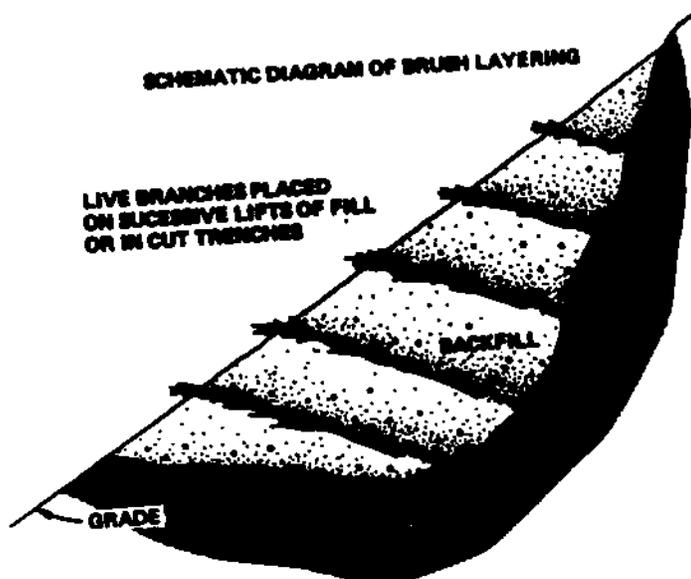
Figure 29. Schematic diagram of brush layering
(from Leiser 1983)

c. Brush layering. Brush layering is a treatment where live willow branches are placed in a "V-like" trench cut into the face of the slope. The trench runs parallel to the contour of the slope. The willow branches are laid in the trench to form a 4-6" layer of criss-crossed stems that is backfilled leaving only the top 6 inches or so of the willow exposed for sprouting (encl. 3, from Allen and Klimas, 1986²). This treatment should be installed about 5 vertical feet above the root wads. Depending on the terrain conditions, another brush layer might be employed further up the slope.

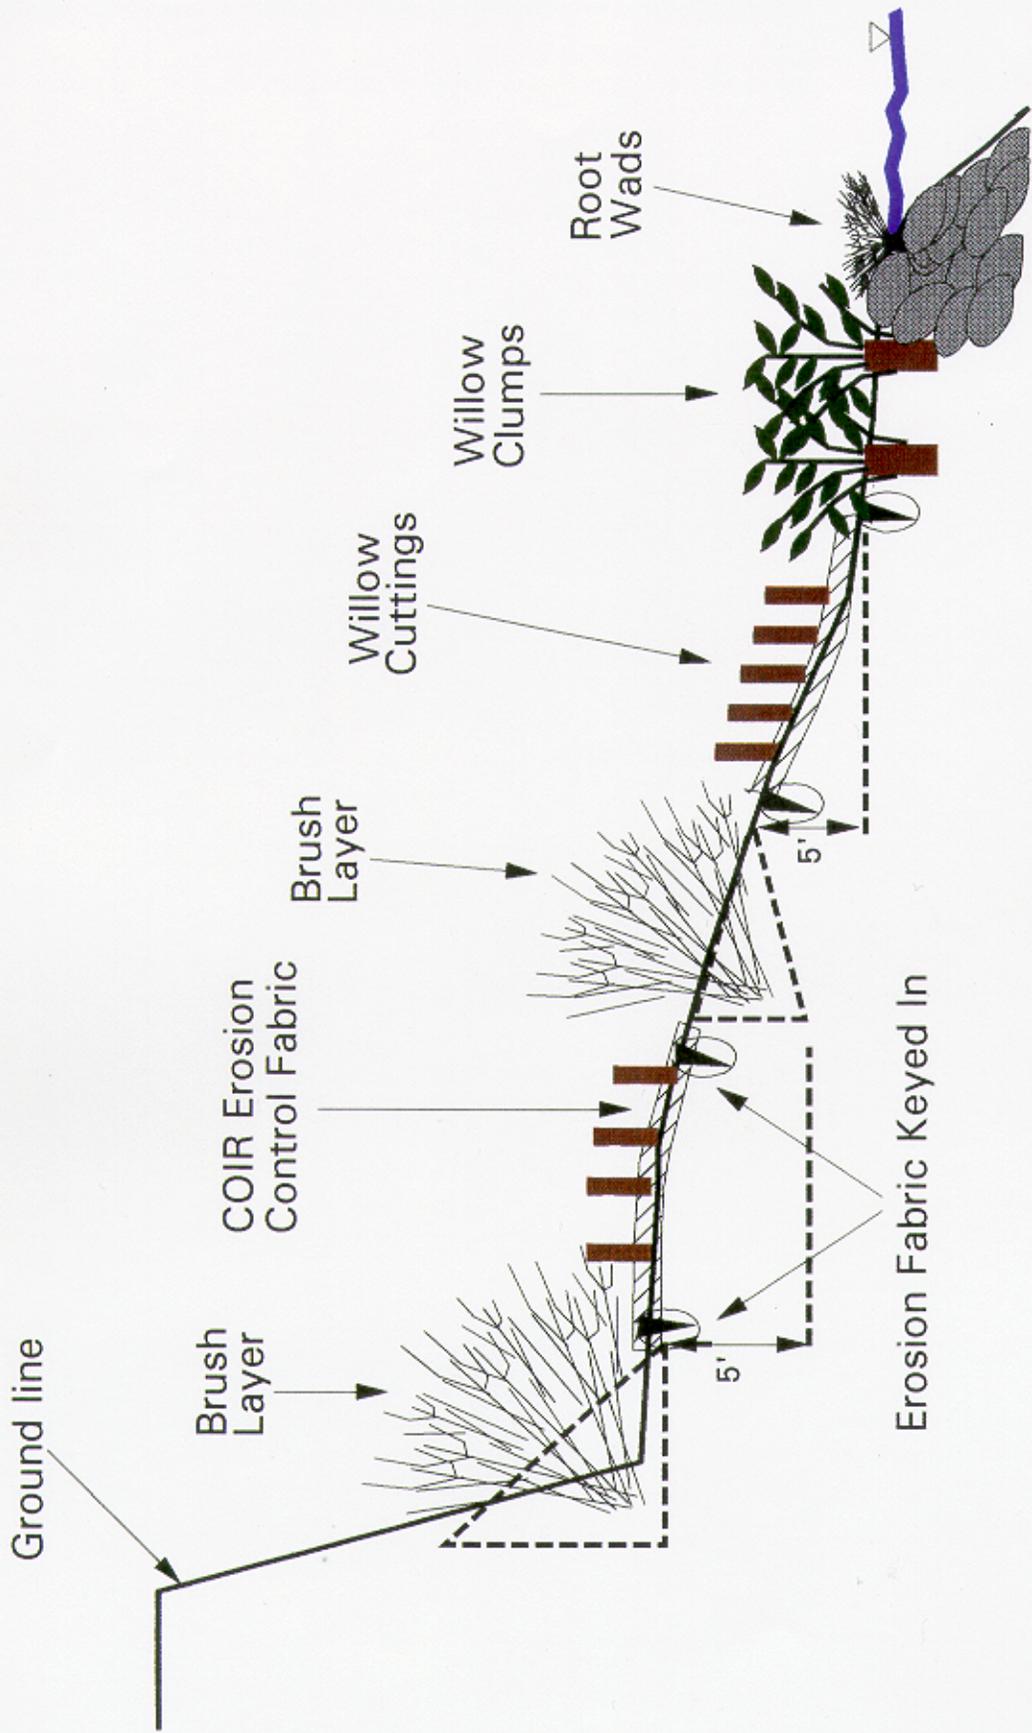
Stone/Rock Toe

Profile (Not to scale)
 Bioengineering Treatments
 Big Cypress Bayou

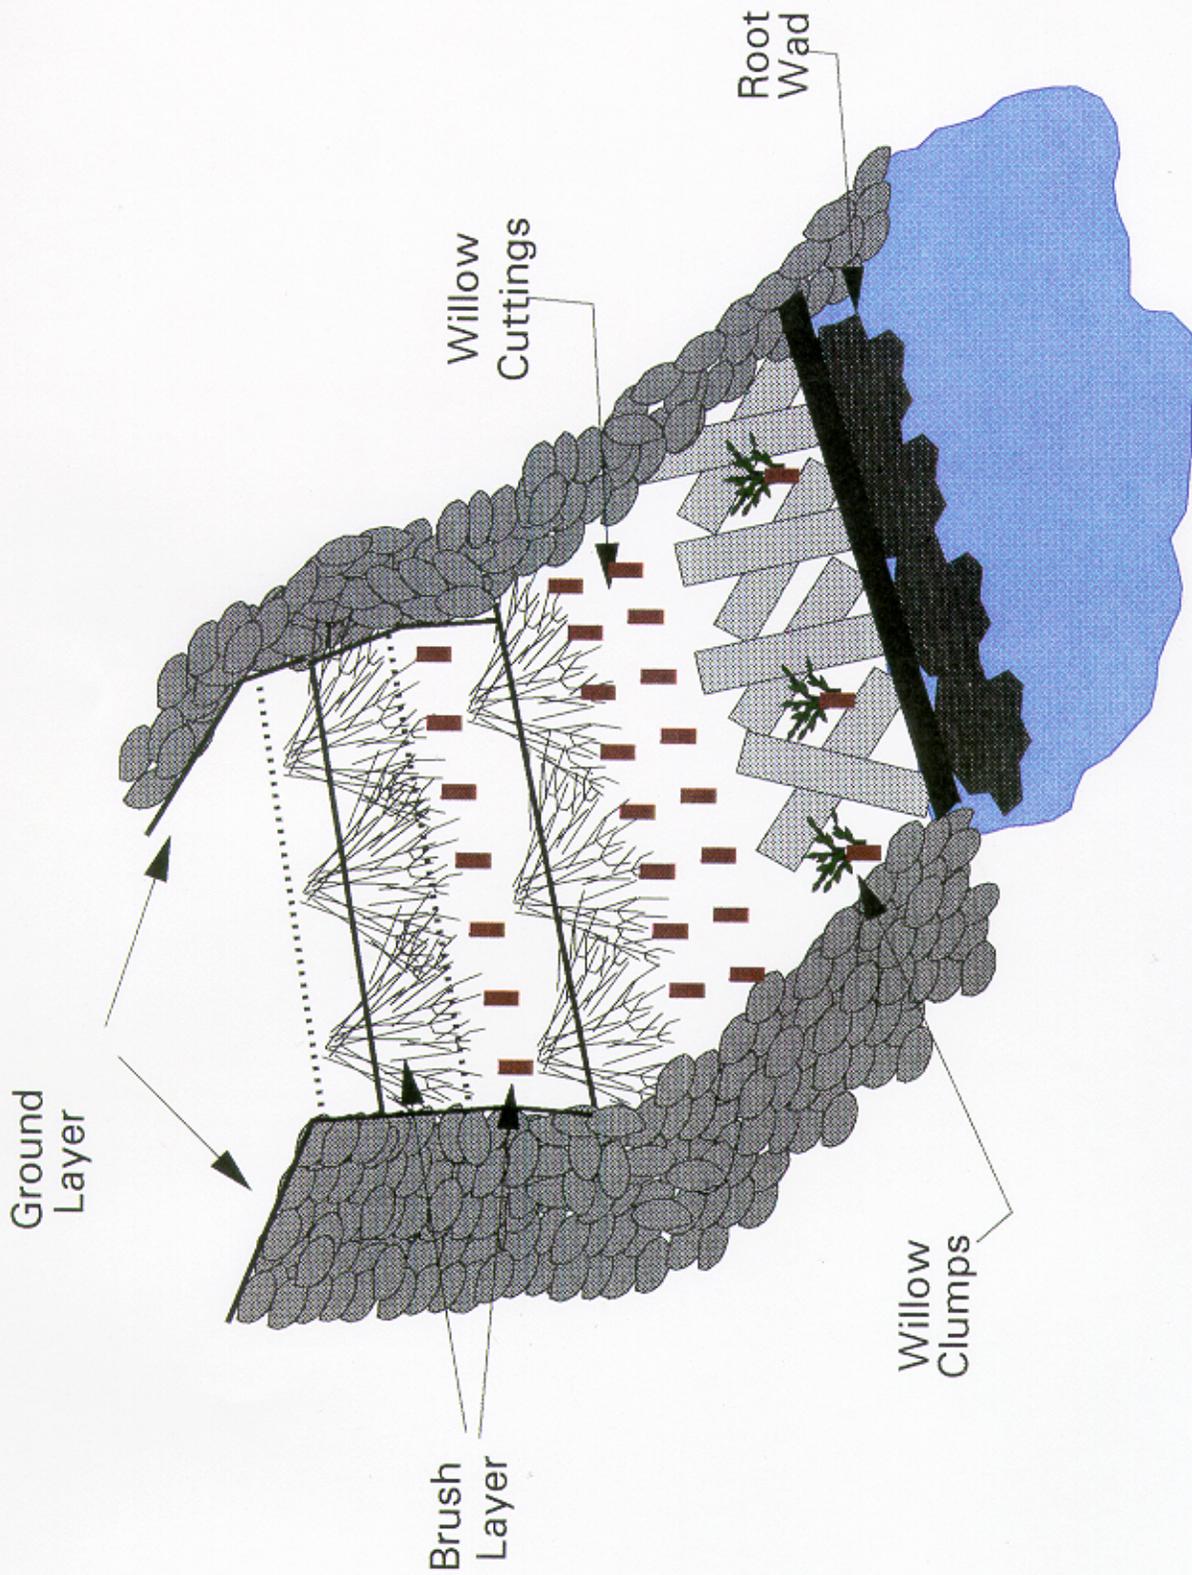
Perspective View (Not to scale)
 Bioengineering Treatments
 Big Cypress Bayou
